# the Conduit

A quarterly publication from  
M&M Engineering Associates, Inc.

Vol. 11, No. 2

## Glossary of Boiler Tube Microstructures and Its Use to Verify Oxide Thickness Temperature Estimations

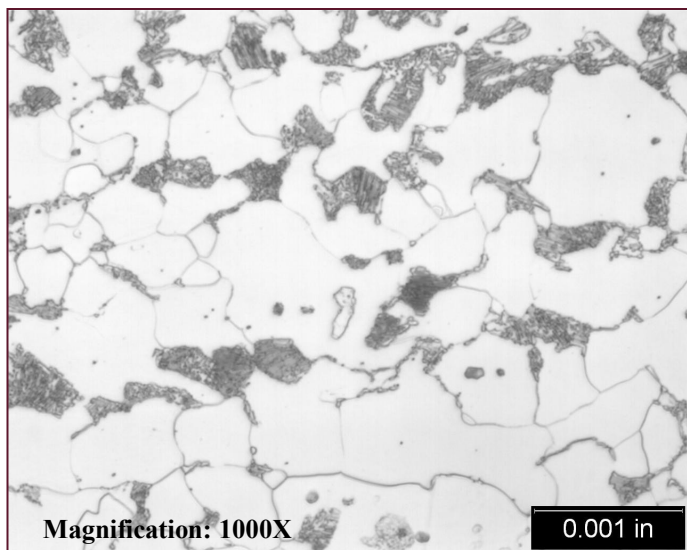
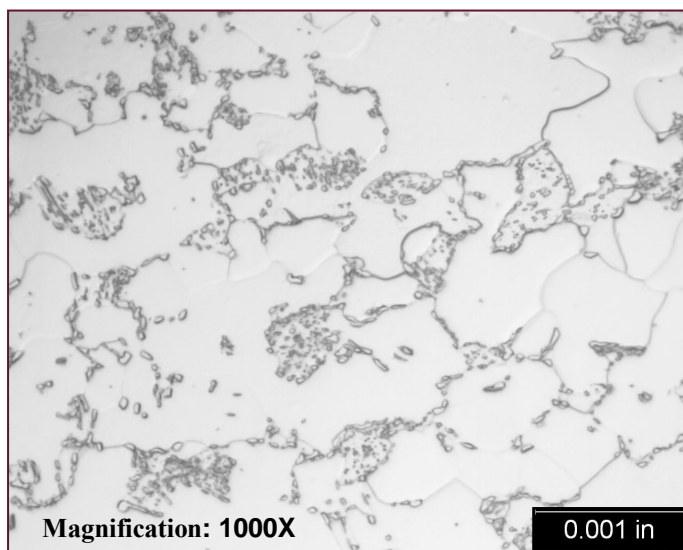
Figure 1: Photomicrographs show SA-210, Grade A-1 in the as-received condition and after 5 hours at 1300°F (704°C). 0.010 inch is equivalent to 0.254 mm. Sample was etched using Picral-Nital.

compared as-received and after heat exposure to show the change in microstructure. SA-210, Grade A-I is a medium-carbon steel commonly used in boiler and superheater tubes and has a maximum of 0.27 percent carbon. The as-received microstructure of the A-I material (shown in Figure 1) is a mixture of ferrite and pearlite. This can be compared to the microstructure after five hours at 1300°F (704°C), also shown in Figure 1. As the material ages, the carbide morphology in the pearlite breaks down. Initially, the small discrete carbides on the crystallographic planes agglomerate into larger, more visible precipitates. With additional time, these carbides further degrade and release carbon that migrates to the grain boundaries and forms an intergranular carbide precipitate.

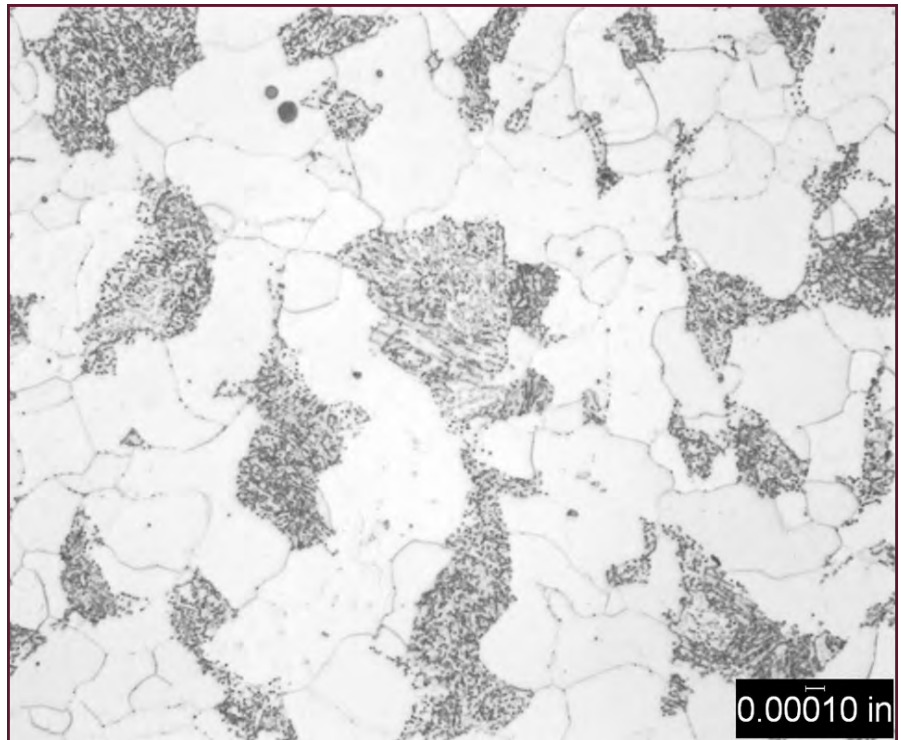
Figure 2. Photomicrograph shows the condition of the T2 superheater tube after 60,000 hours of service. Sample was etched using Picral-Nital.

A superheater tube was received for a metallurgical assessment. The tube was made of SA-213, Grade T2<sup>2</sup> and had been in service for approximately 60,000 hours. No failure was observed in this tube sample; however, several failures occurred in this particular superheater. The microstructure of the tube is shown in Figure 2 and was typical of like-new T2 material with bainite colonies and dispersed carbides. The internal oxide thickness was measured as 0.020 inch (0.051 cm), which is unreasonably large for a tube with so few operating hours (Figure 3). Using internal oxidation growth rate data available for chromium-molybdenum steels<sup>3, 4</sup>, this translates to an equivalent tube temperature between 1200°F (649°C) and 1300°F (704°C). However, the microstructure in Figure 2 is not consistent with this calculated temperature exposure and is more in-

line with the as-received condition of T2. The microstructure shows that the oxide thickness measurement was not a good estimate of operating temperature and the oxide was the result of some other process. In this case, some of the deposit likely resulted from carry-over from the steam circuit and was not formed *in situ*.

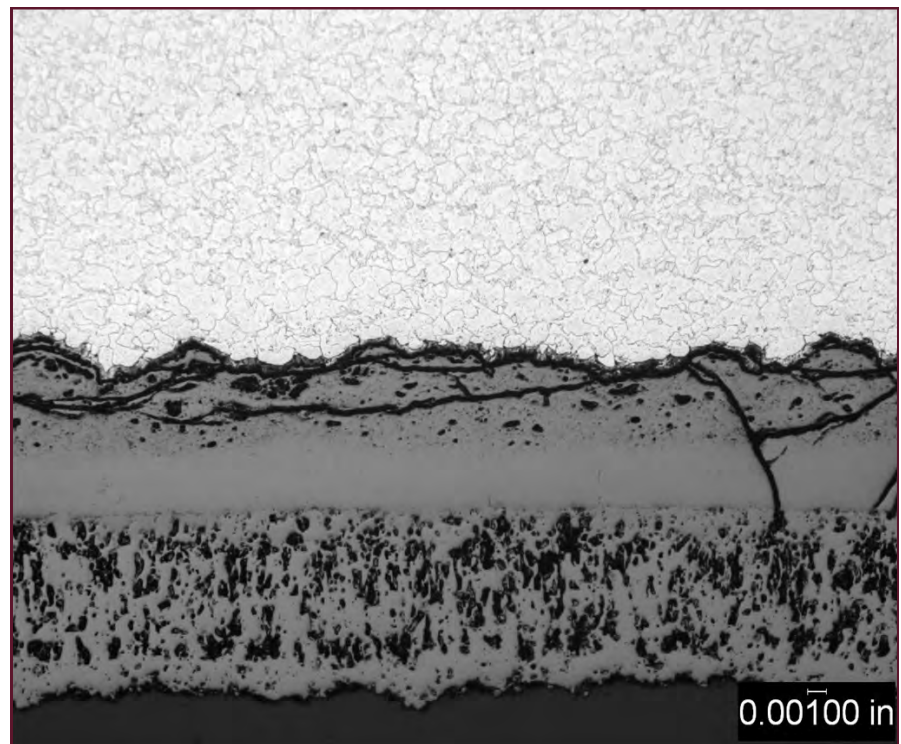
Figure 3. Photomicrograph shows the oxide thickness (0.020 inch) on the internal surface of a T2 superheater tube. Sample was etched using Picral-Nital .

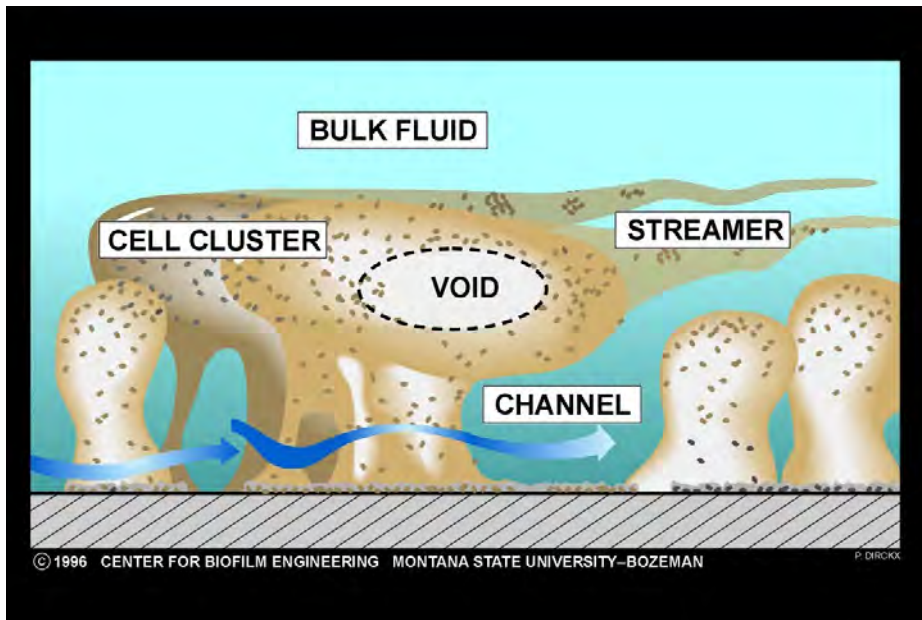
Figure 1. Biofilm

environmental changes including biocide addition (Figure 1). Underneath the biofilm and adjacent to the metal surface, waste products from the bacterial respiration can accumulate. They are typically more acidic than the bulk cooling water. These conditions are conducive to dealloying of copper alloys. Dealloying will occur underneath the biofilm when all the components of the electrochemical/galvanic cell (cathode, anode and electrolyte) are in electrical contact with one another. In the case of dealloying of copper alloys, the copper acts as the cathode, the zinc or nickel or any other less

To protect against dealloying of copper alloys by microbiologically influenced corrosion, the proper selection and concentration of biocides must be used control biofilms. Because biocides do not completely remove the biofilm, periodic mechanical removal of the biofilm (e.g., nylon bristle brushes or scrapers) and any debris in the tube, is critical.

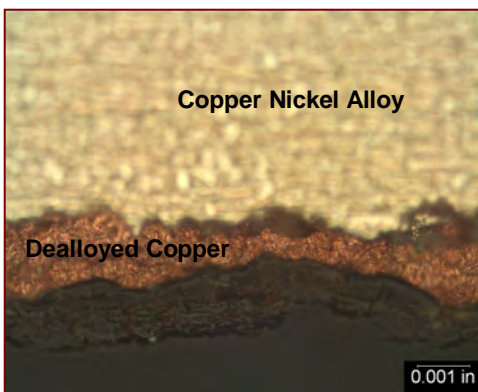
The result of dealloying is a metal matrix where the less noble element in the alloy has oxidized, causing it to become soluble and dissolve. The remaining copper metal has a spongy appearance and the metal has changed from brass color to copper color (Figure 2). The copper sponge has very little remaining structural strength. This can lead to a brittle and sometimes catastrophic failure of the tube. The extent of the dealloying in this condenser tube can be seen in Figure 3. Figure 4 shows an elemental

Figure 2. Pure copper remains after the nickel has been removed.

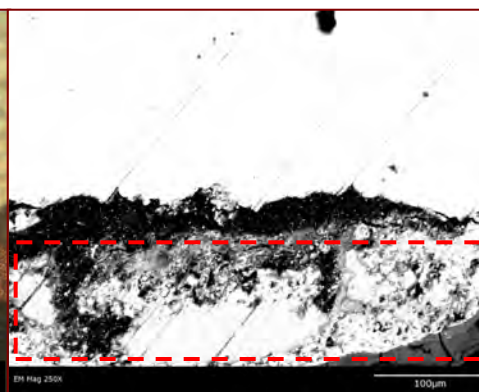
Figure 3. The area where dealloying has taken place is inside the red box. This same area is shown in Figure 4.

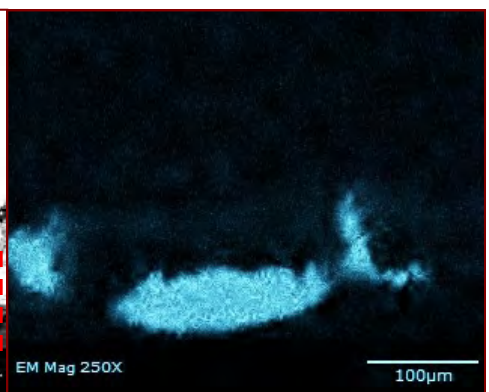
dot map of the dealloyed area generated by energy dispersive X-ray spectroscopy (EDS). The dot map highlights the presence of a single element in the matrix, in this case nickel. Note the relative absence of nickel in the area where dealloying has taken place. Established biofilms are thicker and better at developing types of bacteria that generate strong corrosive acids. While there is nothing that can completely prevent biofilm formation, controlling biofilm development with biocides minimizes the potential for dealloying. In many cases, copper alloys are being replaced by stainless steel or titanium in condensers which are more corrosion resistant but have a lower thermal conductivity than copper alloys, so there is a trade-off. Also, stainless steel tubes are also susceptible to MIC attack.

Figure 4. Absence of of Nickel (Blue) as seen in the EDS dotmap where the dealloying has occurred.

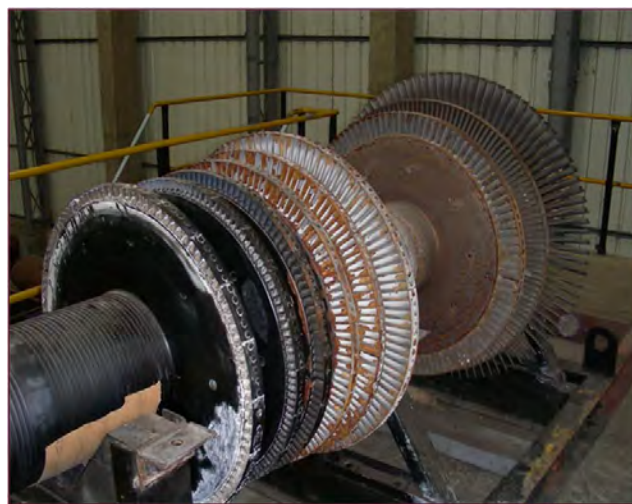
**BEFORE**

The mill purchased a 10 MW steam turbine with extraction points to supply the mill process and a small condenser for the remaining steam. After a short period of operation, the steam turbine developed performance issues. When the mill opened the steam turbine, they found it covered in white and rust colored deposits. Analysis showed that the deposits were predominantly silica and caustic. The turbine manufacturer recommended M&M Engineering to the mill. We visited the site, evaluated the water and steam chemistry program, determined the probable causes of the deposits and developed a plan for minimizing steam contamination in the future. The recommendations included changes in the boiler operation, chemical treatment, monitoring, and water pretreatment practices. We provided a new set of chemistry guidelines and provided training to the operators and lab personnel on testing, water treatment equipment, and handling

**Figure 1. After only a short period of operation, the turbine became contaminated with deposits.**

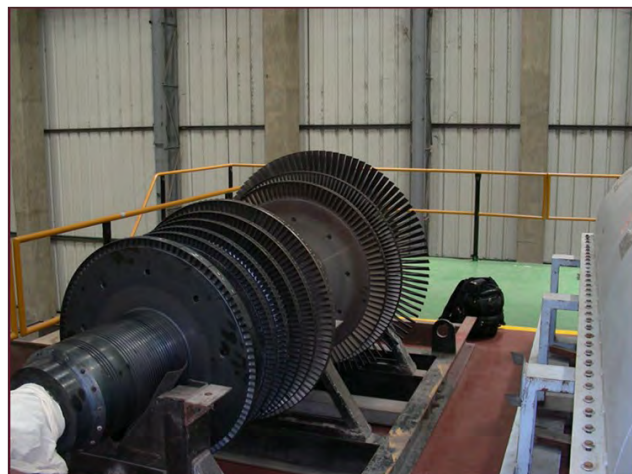
**AFTER**

chemical upsets. The mill took action and made many of the recommended changes before the next campaign. A year later, M&M Engineering was asked to return during the mill outage where they were again removing the turbine cover for inspection. We found the turbine was far cleaner with minimal deposits. While there, we were able to find other ways for the plant to improve the reliability and reduce the costs associated with their steam cycle.

**Figure 2. The mill improved operating practices and chemical monitoring that made a tremendous improvement in the turbine’s appearance.**
