the Conduit

Inspection and Repair of Batch Digesters Part 2 of 3

By Max Moskal

Part 2 – Application and Repair Strategies

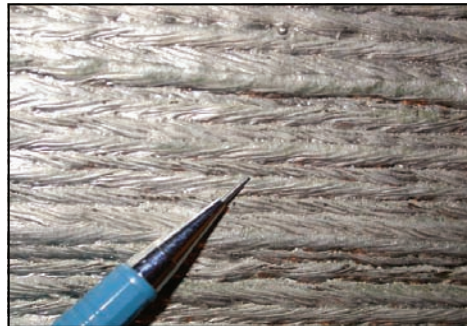
Type 312 Stainless Steel
GMAW
New

Figure 1. Examples of stainless steel gas metal arc welded (GMAW) Type 312 stainless steel overlay in the batch digester showing as-welded (top) and with two different stages of corrosion deterioration.

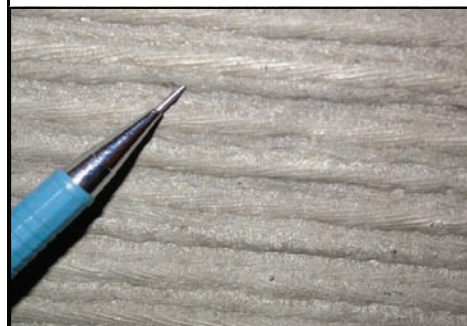
Type 312 Stainless Steel
GMAW
Light General Corrosion

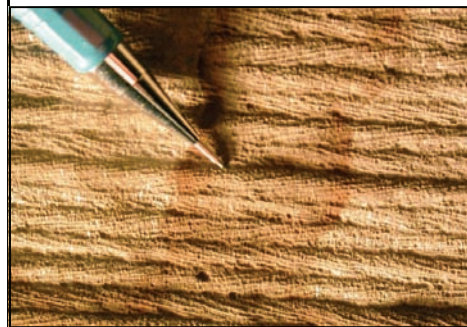
Type 312 Stainless Steel GMAW
Severe General Corrosion
(Still serviceable.)

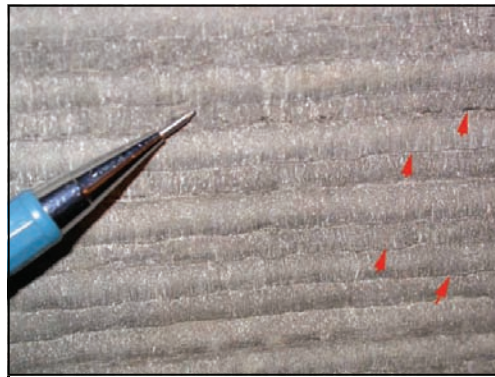
Type 309L Stainless Steel SAW
Moderate Corrosion Inter-Bead Attack
(Arrows)

Figure 2. Moderate corrosion attack and inter-bead deterioration of Type 309L stainless steel SAW overlay (top). The lower two examples show SAW overlay that has deteriorated severely—the overlay should be replaced.

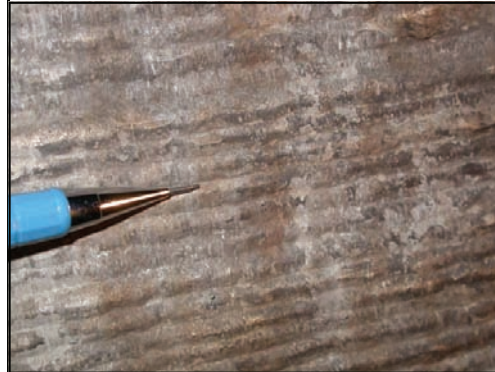
Type 309L Stainless Steel SAW
Severe Deterioration
(Replacement Needed)

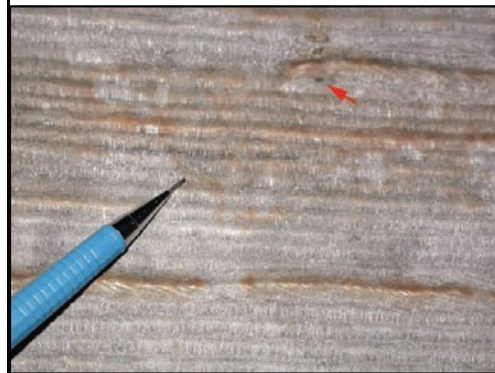
Type 309L Stainless Steel SAW
Severe Corrosion
Carbon Steel Exposure at Arrow

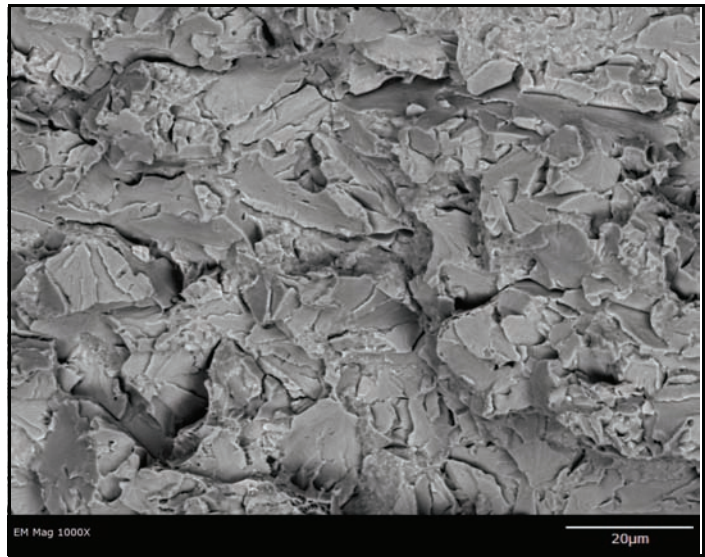
Figure 1. SEM backscattered electron image shows a cleavage-type fracture surface on a low-alloy steel that cracked at cryogenic temperatures (1000X).

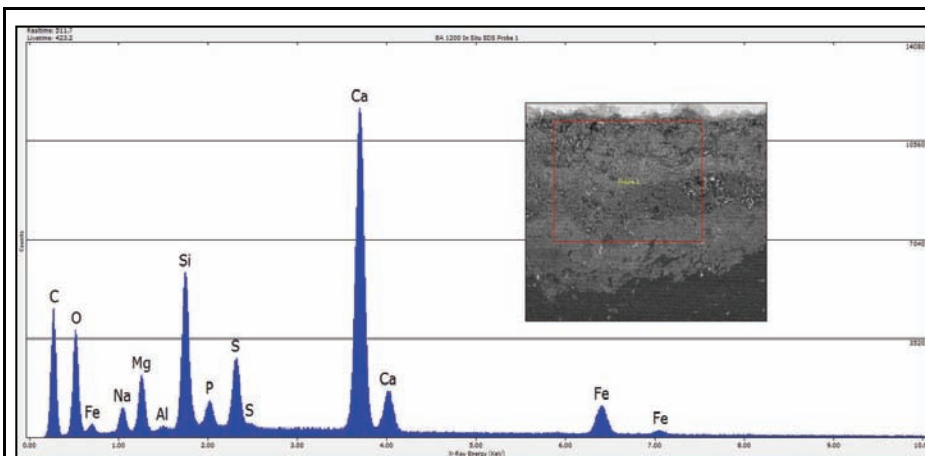
Figure 3. EDS Spectrum for a debris sample from an obstructed superheater tube.

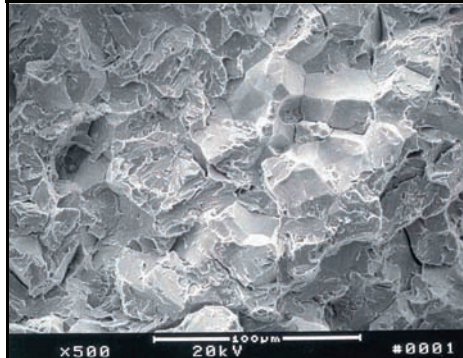
Figure 2. Hydrogen damage induced by weld repair.

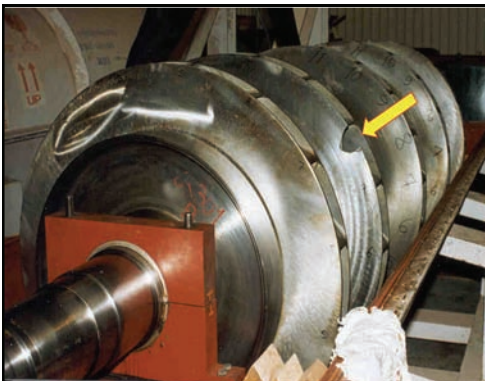
Figure 1. Failure in centrifugal compressor initiating in fabrication weld.
