the Conduit

February 2007

Monitoring Corrosion Rates in Cooling Water

Oxygen Pitting and the Importance of Magnetite Film Maintenance in Low Pressure Boiler Water

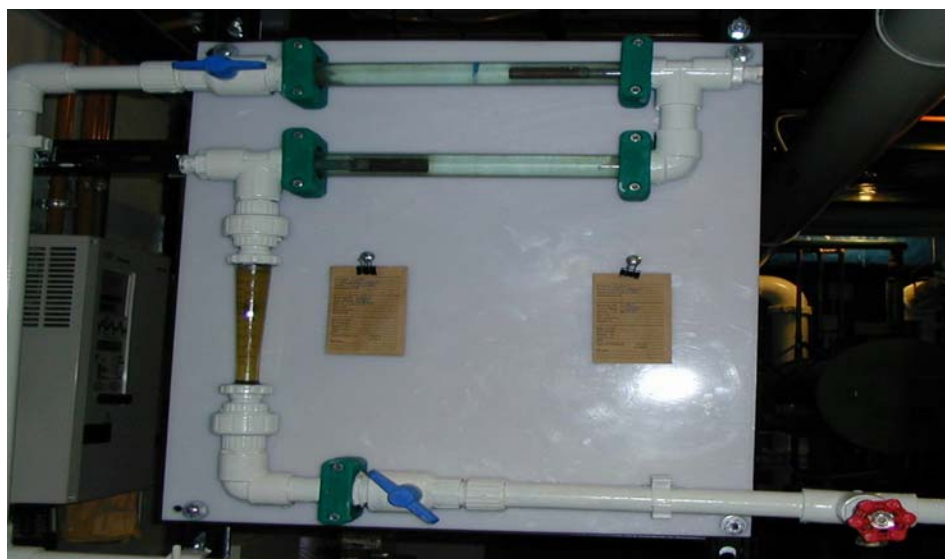
The most common method of corrosion rate monitoring consists of routing a bypass stream of cooling water through a "corrosion coupon rack" (Figure 1.) containing

Figure 1. Corrosion Coupon Rack.

pre-weighed metal specimens (corrosion coupons). This particular design has the advantage of utilizing clear plastic tubing that allows observation of the condition of the coupon. The design also incorporates a flow-measuring device (rotameter) so that adequate flow through the corrosion coupon rack can be confirmed. In addition to bypass corrosion coupon racks, there are coupon holders (Figure 2) that allow

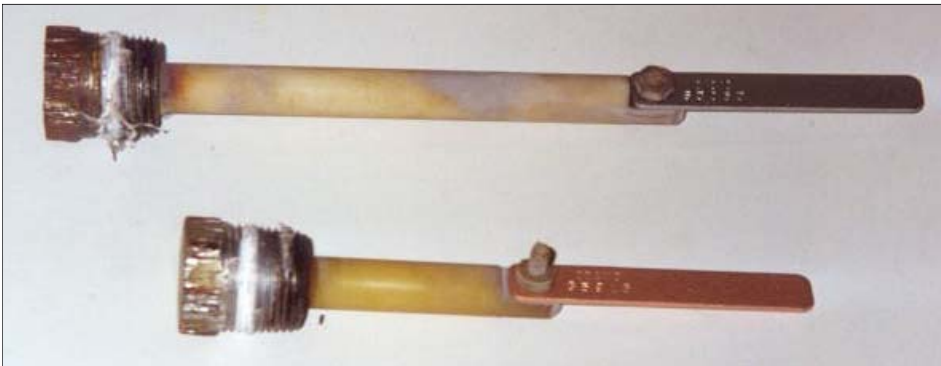
Figure 2. Coupon Holders.

the corrosion coupons to be inserted directly into the flowing process stream and correctly orientated.

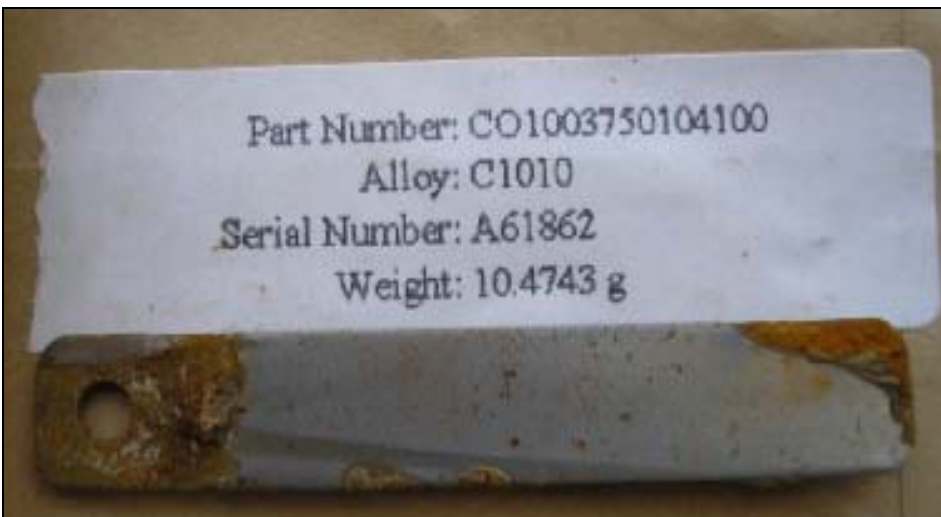
Figures 3A and 3B show both sides of the same corrosion coupon. The corrosion is minimal on one side of the coupon (Figure 3A) and heavy on the other side of the coupon (Figure 3B). This type of corrosion pattern is usually an indicator of inadequate flow through the corrosion coupon rack.

Figure 3A. Side of Corrosion Coupon with Minimal Corrosion.

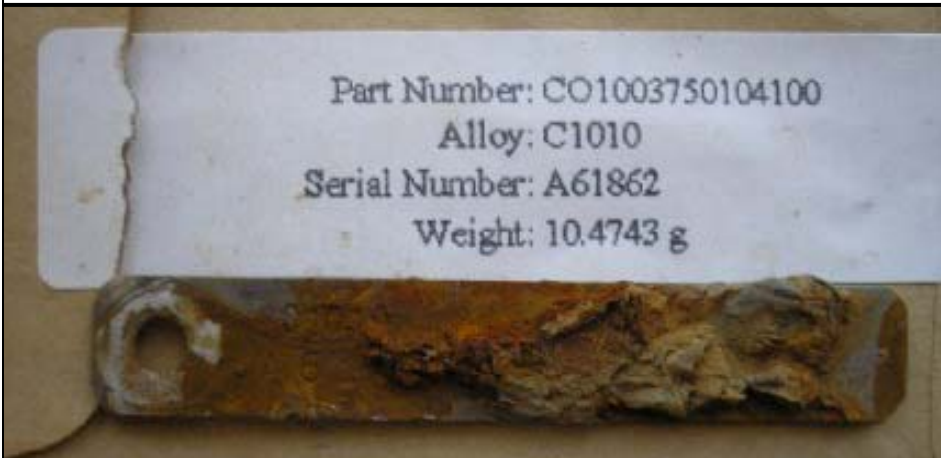
Figure 3B. Side of Corrosion Coupon with Heavy Corrosion.

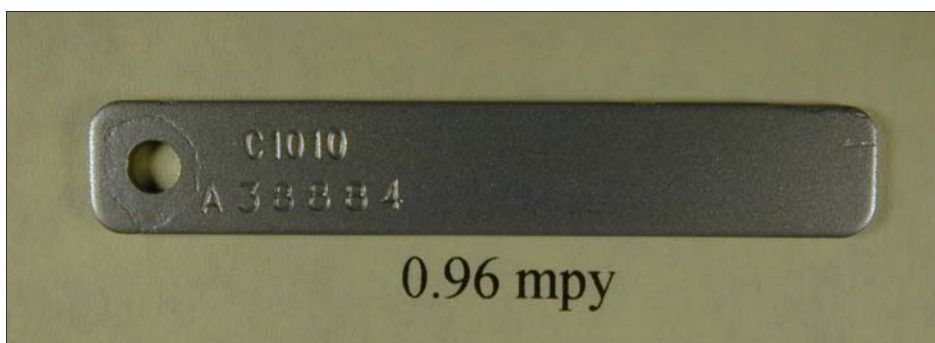
Figures 4A, 4B and 4C show carbon steel corrosion coupons from different systems after 90 days exposure (after cleaning). The

measured corrosion rate of the coupon shown in Figure 4A was about 1-mpy. There is little observable corrosion attack. The corrosion rate of the coupon shown in Figure 4B was approximately 3-mpy. The impact of corrosion is visible. The corrosion rate of the coupon shown in Figure 4C was approximately 13-mpy. The impact of corrosion is very visible.

Figure 4A. Coupon with Approximately 1-mpy Corrosion Rate.

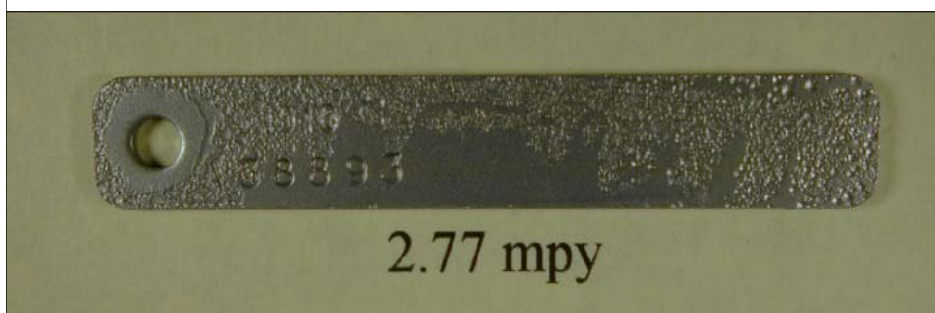
Figure 4B. Coupon with Approximately 3-mpy Corrosion Rate.

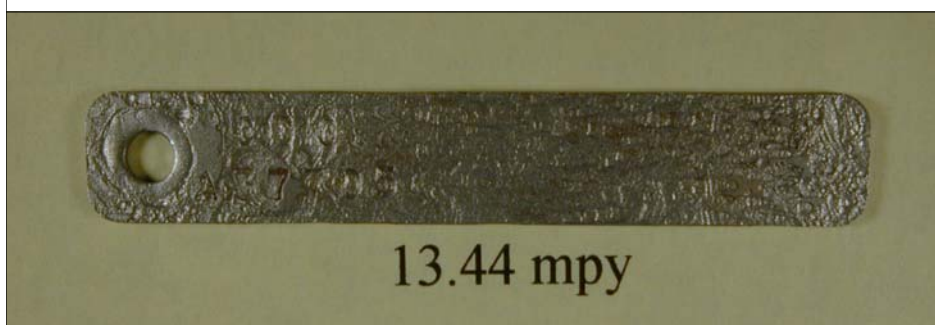
Figure 4C. Coupon with Approximately 13-mpy Corrosion Rate.

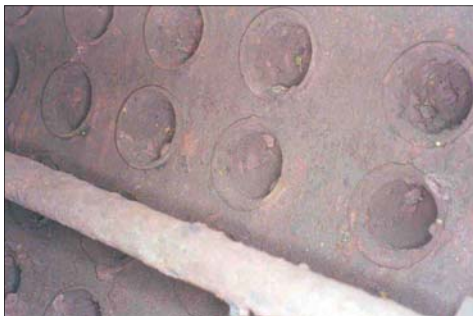
Oxygen pitting is one of the most frequent corrosion mechanisms identified in low pressure boilers. Once initiated, oxygen pitting is difficult to stop (Figure 1.). Pitting leads directly to tube penetration and failure of the boiler. Most corrosion mechanisms require very specific conditions—this is true for oxygen pitting. Combinations of two or more of the following conditions are usually required for significant damage to occur.

Figure No.1. Oxygen Pitting in Steam Drum.

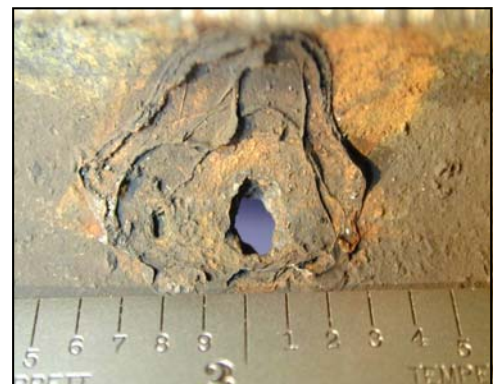
Oxygen pits are rather easily identified by their appearance (Figure 2). In fact, a close observation of a representative sample of several oxygen pits can often reveal whether the pitting is active or not. When active oxygen pits are carefully rinsed out with plain water, shiny, unpassivated steel can be seen at the bottom of the pits. The bottoms of inactive pits, on the other hand, will appear dull and coated with a grey-to-black magnetite film.

Figure 2. Typical Oxygen Pit.
