the Conduit

Winter 2007-2008

Stress Corrosion Cracking in an Ethanol Plant

By David Daniels

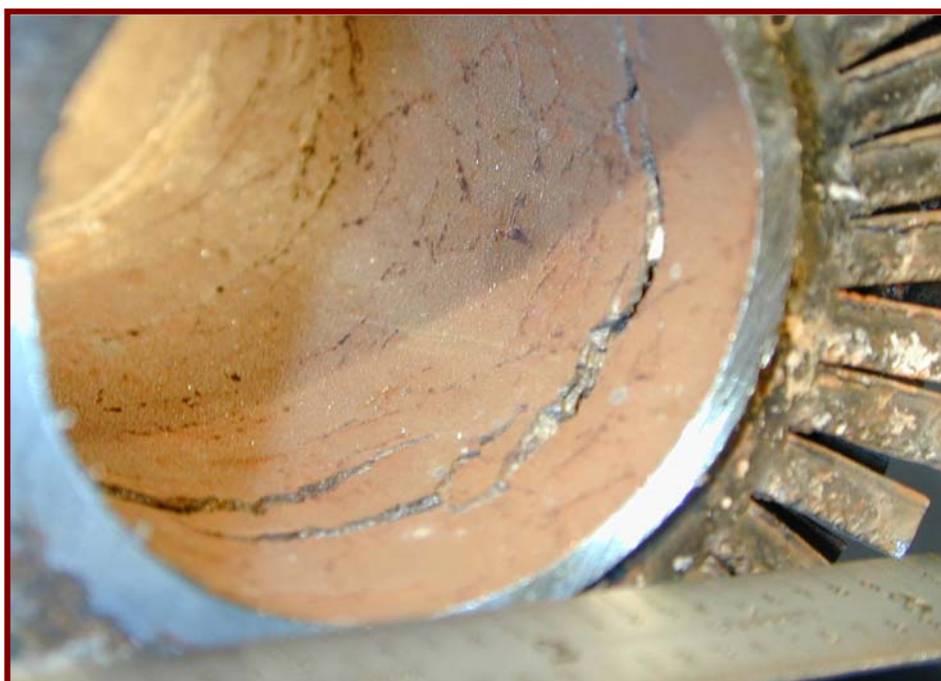
Figure 1. Multiple cracks on this stainless steel feedwater pre-heater tube actually started on the OD of the tube.

Recently, M&M Engineering Associates, Inc. examined six finned stainless steel preheater tubes from an ethanol plant. The tubes contained numerous circumferential cracks that went all the way through the tube walls. However, there was very little deposit and no evidence of pitting or corrosion on the waterside surfaces (Figure 1).

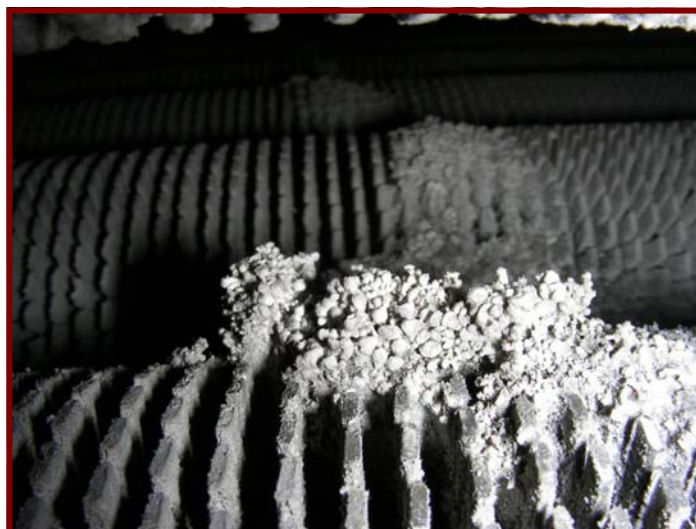
Figure 3. Deposits on the cook water tubes.

Initially, it was suspected that there was a leak in the cook water tubing that contaminated the downstream tubes, but visual inspection of these tubes found no obvious leaks. However, there were deposits on the cook water tubes (Figure 3) and metallurgical analysis found incipient chloride stress corrosion cracking on these tubes also.

M&M Engineering was able to trace the source of the chloride and made recommendations to the plant to eliminate this as a potential source in the future.

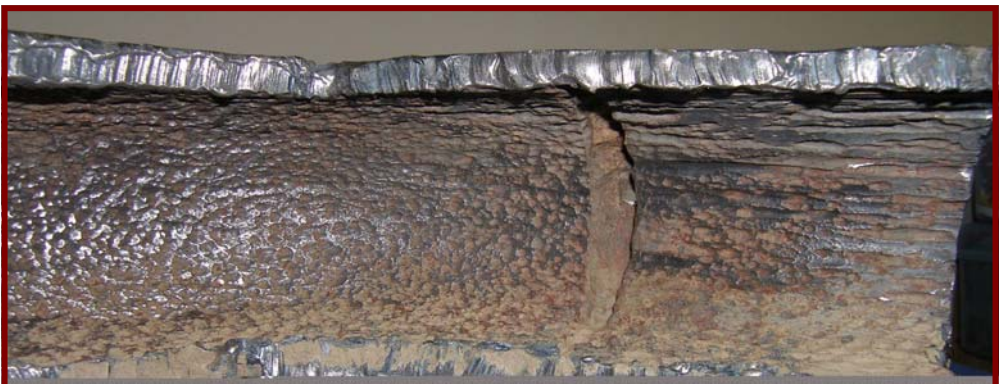
Some incidences of OTSG corrosion (Figure 1) are related to the recent increase in the bicarbonate alkalinity of the feedwater blend. Since the rate of replacement of fresh water and

Boiler tubes provided to us clearly show two examples of severe localized corrosion, which are classic examples of FAC (flow assisted or accelerated corrosion). In one case, the dimpled or round-bottom pits, the longitudinal grooves in deep radial channels caused the loss of that magnetite film from erosion due to turbulent water flow within the temperature range required for FAC. In these boilers, magnetite formation/reformation is removed in part by the effect of carbonic acid formed when the carbon dioxide gas, liberated from the decomposition of bicarbonate alkalinity in the boiler water, re-dissolves in the water at the heat transfer surface of the tube. The repetition of this magnetite film formation and removal process is a corrosion mechanism and results in the extreme metal loss in the tube bend. Excessive alkalinity (and poor alkalinity and pH control) can also serve to accelerate dissolution of magnetite. This can be called a complex single-phase FAC.

Figure 1. OTSG return pass bend (longitudinal section) showing typical single-phase FAC “orange peel”, along with grooves (merged pits).

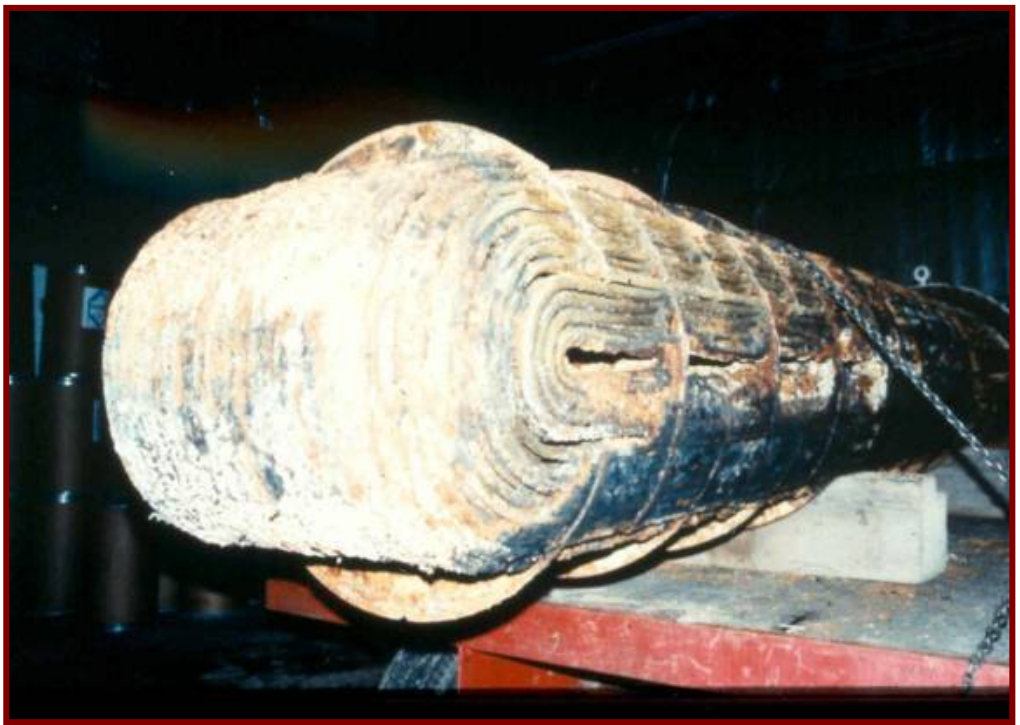
Figure 1. Severely scaled floating head tube bundle (cooling water on shell side).

This latent problem should have been anticipated and prevented by the technical service representatives of the refinery’s water treatment chemical supplier, but it was not and, after several months of operations under these adverse conditions, inspections during a scheduled multi-unit turnaround revealed a severe heat exchanger fouling condition. The additional maintenance that the

Before the problem was solved, it made the refinery question the value and even the feasibility of continuing its use of reclaimed water. Fortunately, the problem's root cause was properly determined and proper cooling water quality was promptly
