the Conduit

High Energy Piping Evaluation, Part 2 of 3

Forensic Investigation of a Gas Turbine Event

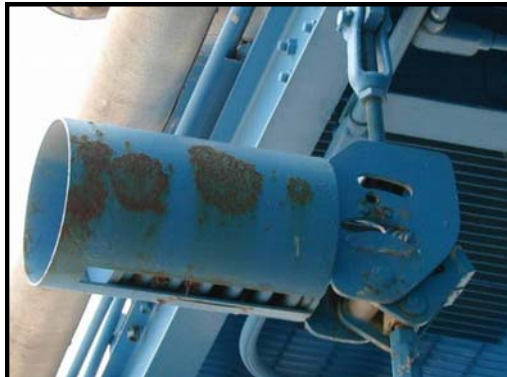
Figure 1. Constant Support Hanger Fouled by Nesting Birds

Although flexible pipe supports are generally reliable, they can be prone to internal mechanical problems such as contamination by fly ash, coal dust, corrosion products, or even nesting birds. Such contaminants can foul the spring within the support and arrest its motion. As an example, Figure 1 and Figure 2 show a constant support hanger fouled by nesting birds causing limited and irregular hanger functionality. Piping systems close to seawater or in paper mills are particularly prone to corrosion due to the ambient corrosive environment. As a result, this can cause load deviations or limited functionality of supports that have been severely corroded (Figure 3).

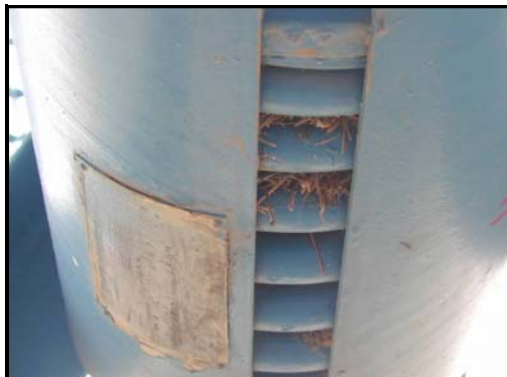
Figure 2. Closer View of Constant Support Hanger Fouled by Nesting Birds

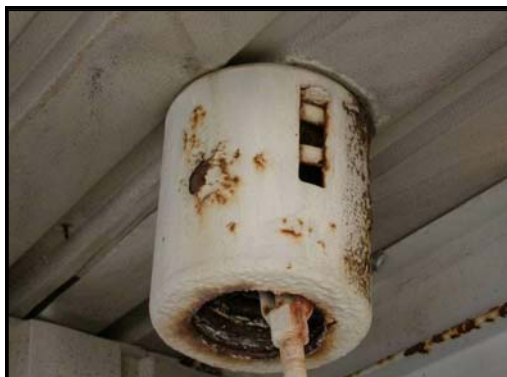
Figure 3. Variable Support Hanger Displaying Severe Corrosion

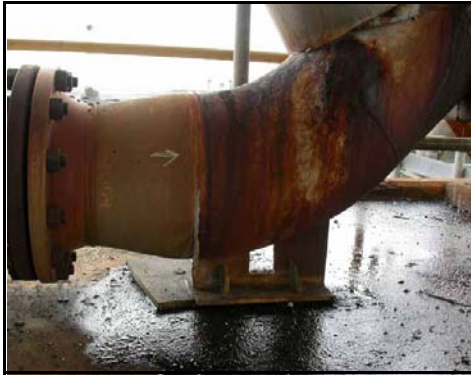
Figure 4. Slide Plate Displays a Dislodged HDPE Pad

between contacting surfaces can impede axial movement. With some rigid supports, an intermediate material may be used between contacting surfaces. The sliding pad may become liberated, as shown in Figure 4, thus causing increased resistance to axial movement.

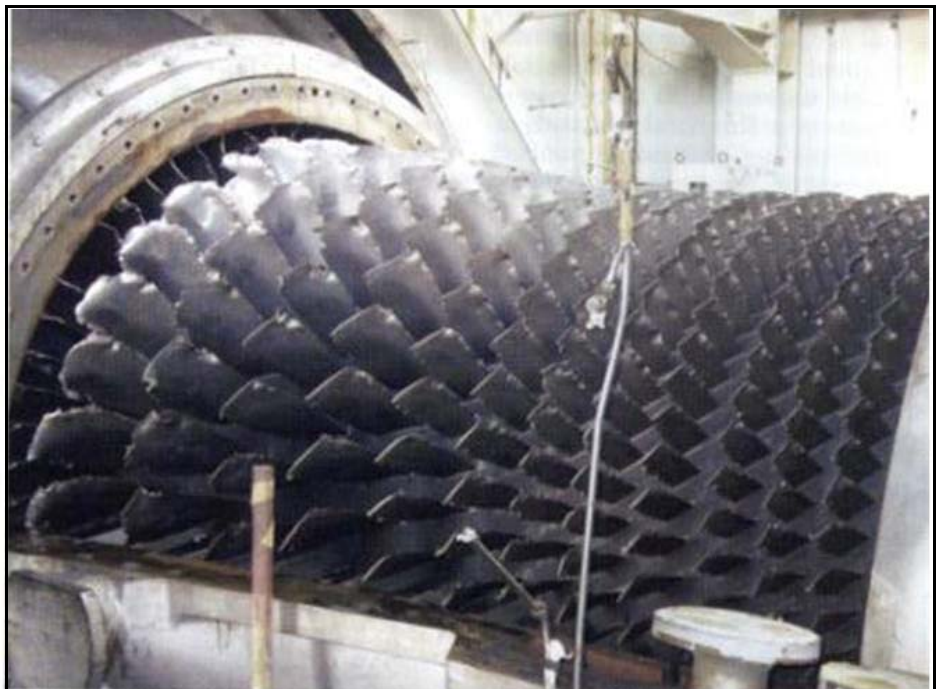
Figure 1. Failure of a first-row blade showing the damage to every stage of the compressor.

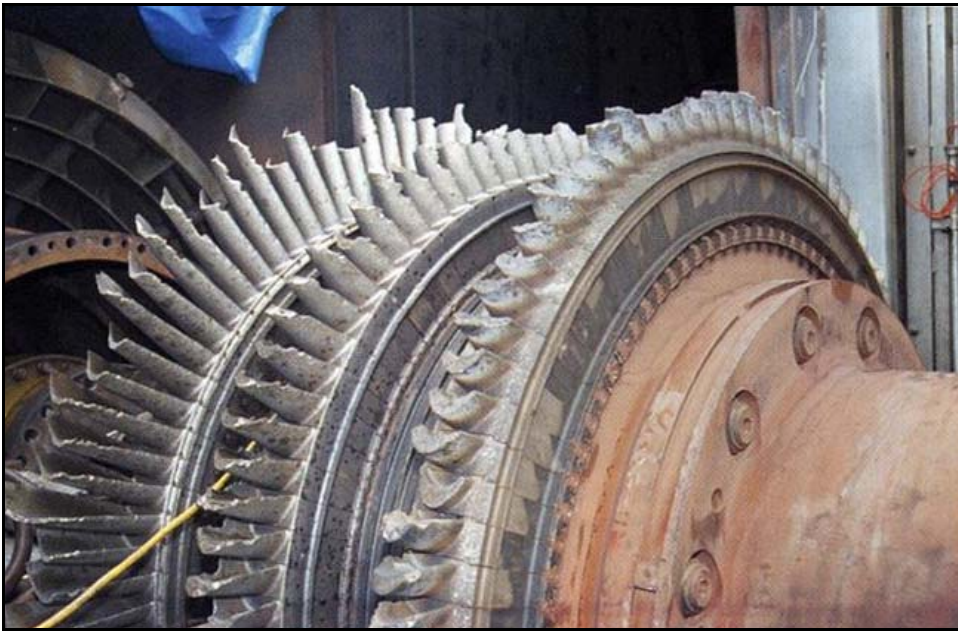
Figure 2. No bucket was left unscathed I this Frame 6 Turbine failure.
