# the Conduit

A quarterly publication from  
M&M Engineering Associates, Inc.

Vol. 11, No. 1

## EPRI Corrosion of Wet Flue Gas Desulfurization Systems

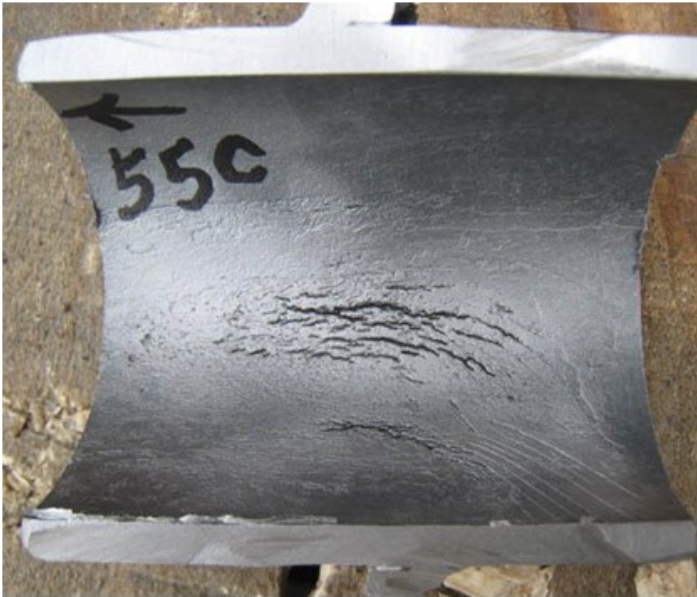
**Figure 1. Stress-assisted corrosion cracking in the tube ID at the smelt box attachment.**

the least recognized form of corrosion in boiler tubes because it begins on the inside of the tube surface and works through to the outside (Figure 1). Deterioration by corrosion may proceed undiscovered until a leak develops. Unless a careful metallurgical examination is made, the problem is often interpreted as simply a leak at a weld flaw. Power boilers are also subject to SAC damage but do not experience the potentially severe consequences of a smelt-water explosion. In the electric utility industry, SAC is referred to as [waterside] corrosion fatigue, and the terminology stems from original work on the problem by the Electric Power Research Institute (EPRI) during the 1980s. The basic terms (corrosion fatigue and SAC) have stuck with their respective industries, but the damage mechanism is identical.

Studies have shown that up to 50% of older recovery boilers have SAC at some locations. Further, that SAC tends to be a relatively slow process and is most commonly found in boilers that have been operating for at least ten years. SAC is almost always found near weld attachments to the tubes, which contribute to local stresses in the tubes as the boiler cycles in temperature and

pressure. The most likely locations for SAC in recovery boilers are the corners of spout openings and wind box attachments, and along floor to sidewall seal scallop bars. These locations, being lower in the furnace, represent a particular hazard should cracks penetrate to allow water to leak into the smelt bed.
