the Conduit

High Energy Piping Evaluation, Part 3 of 3

Inspection and Repair of Batch Digesters Part I of 3

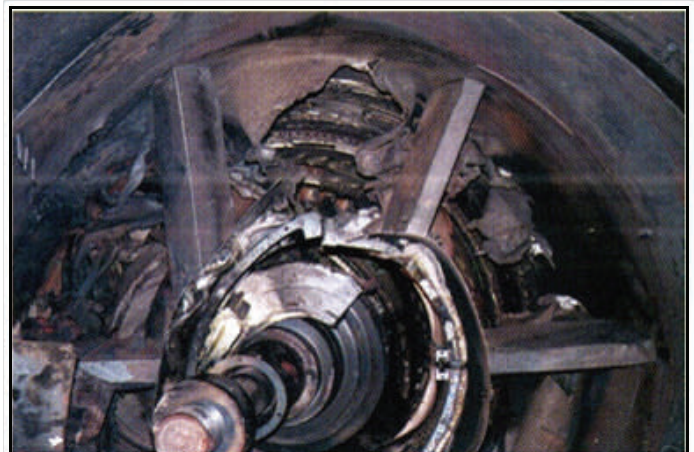
Figure 1. Power turbine failure exhibits considerable collateral damage.

Think Front to Rear. Turbine airflow will sweep liberated debris to the rear of the engine, creating an increasing cascade of damage. The failure often, though not always, will begin at the front or near the front of this damage. Usually damage originating in a row or stage can and will impact the preceding stage by debris being propelled forward. A good example is the liberation of a second stage blade airfoil. It would be knocked forward into the trailing edge of the second stage vane, leaving impact damage in front of the original failed stage.
